**REPUBLIC OF CROATIA  
CROATIAN MINE ACTION CENTRE -  
CENTER FOR TESTING, DEVELOPMENT AND TRAINING**

**„SAMSON 300 “DEMINEING MACHINE  
TESTING REPORT**

Sisak, February 2005

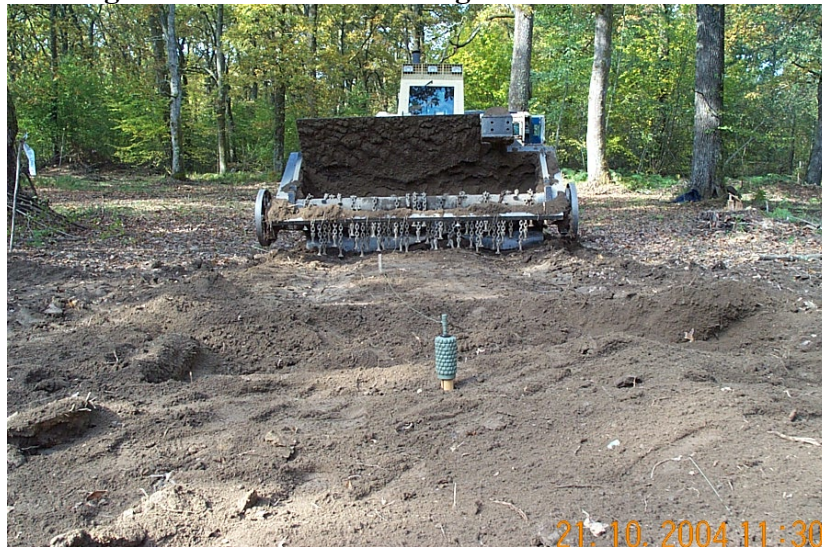
- **First mine** – was placed in front of the machine at around 8 m distance and armed with appropriate fuse. **The mine was shattered by the working tool (flail). Neither the working tool nor the machine was damaged.**
- **Second mine** – was placed in the same manner. **It was shattered by the working tool. Neither the working tool nor the machine was damaged.**

Figure 7 – Testing with PMR-2A mine

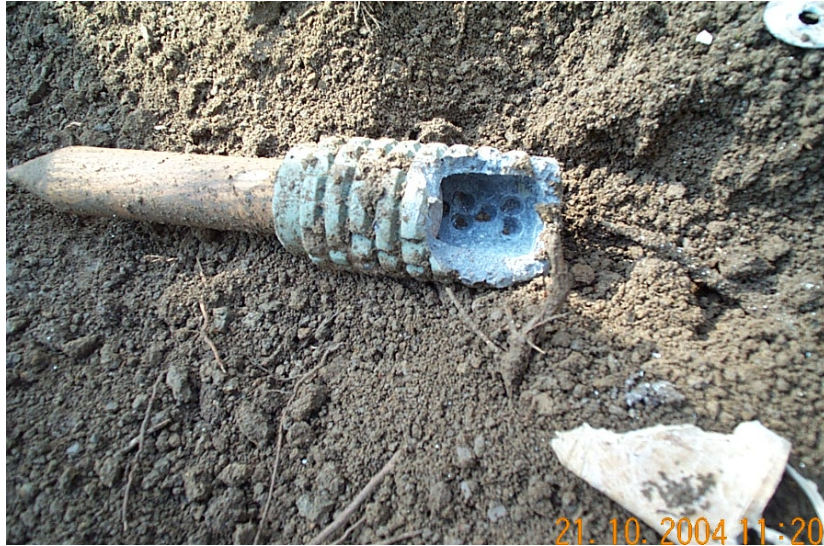
Figure 8 – Shattered remains of the PMR-2A mine

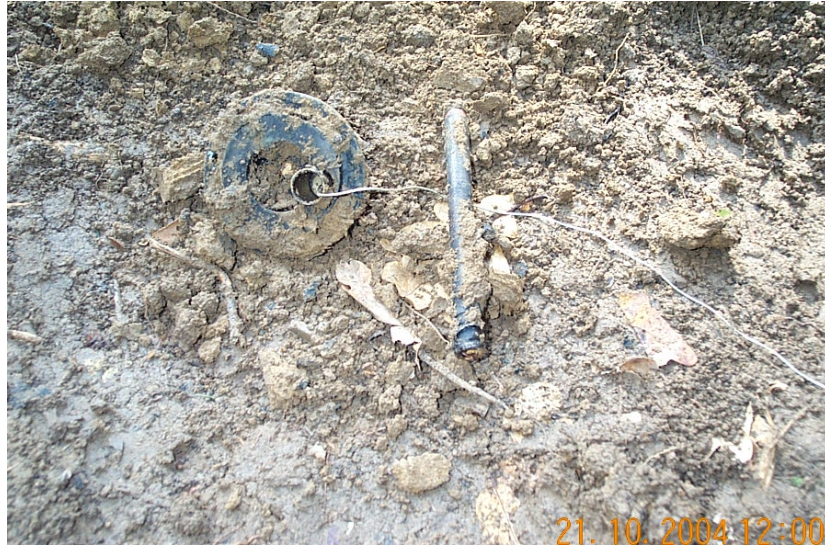
- **First mine** was placed and prepared for tripwire activation. **The mine was activated** by the machine; **the working tool was damaged at some 20 spots** by mine fragments. **The flail cover was penetrated in three places.** **The machine was not damaged.**
- **Second mine** was placed and prepared for pressure activation. **The mine was activated** by the machine; **the working tool was damaged at some 20 spots** by mine fragments. **The machine was not damaged.**

Figure 10 – Remains of the activated PROM-1 mine

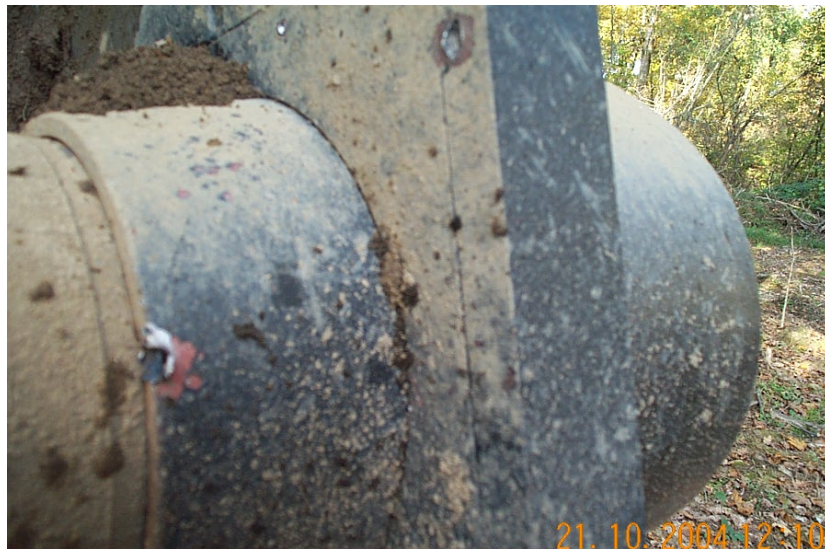
Figure 11 – Damage on the flail inflicted by the PROM-1 mine

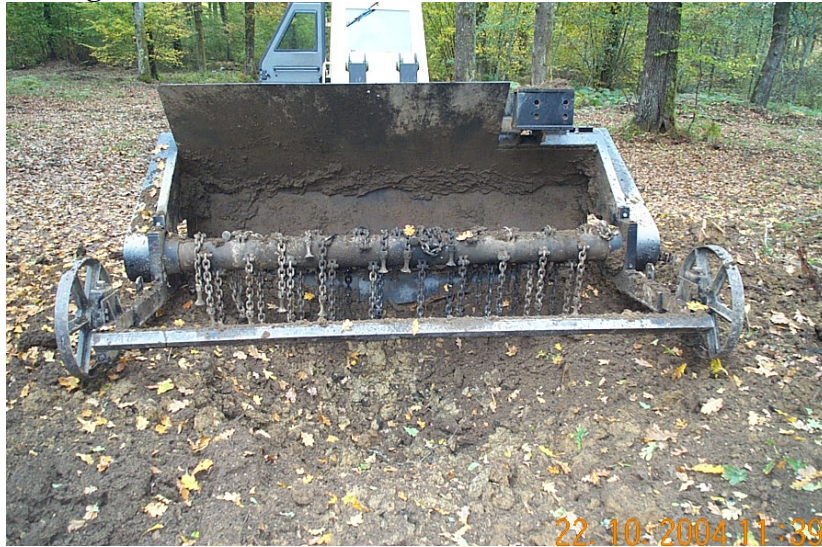
Figure 14 - The crater caused by the activation of a TMA-3 mine

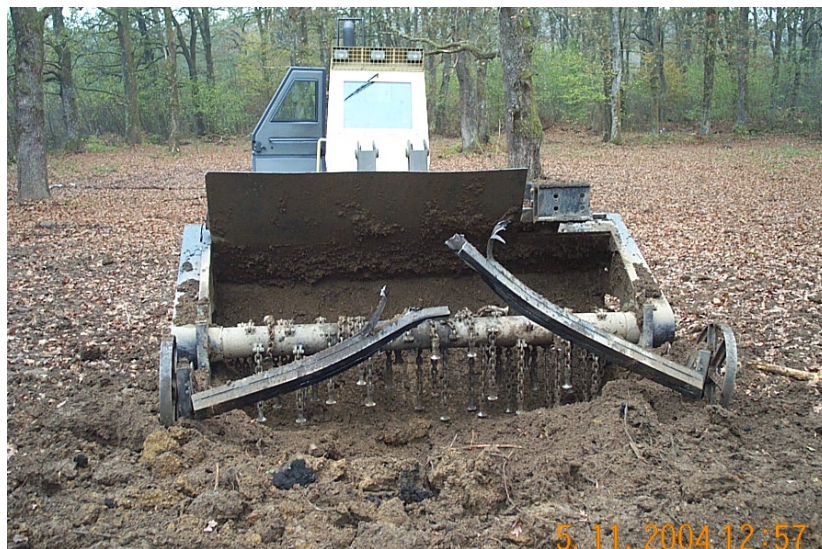
fuse for tilt road activation. **The mine was activated** by the working tool. **The following damage was caused to the machine and the working tool:**

- **The vegetation rod was broken in the middle**

Figure 17 – Damaged vegetation rod after TMRP-6 activation

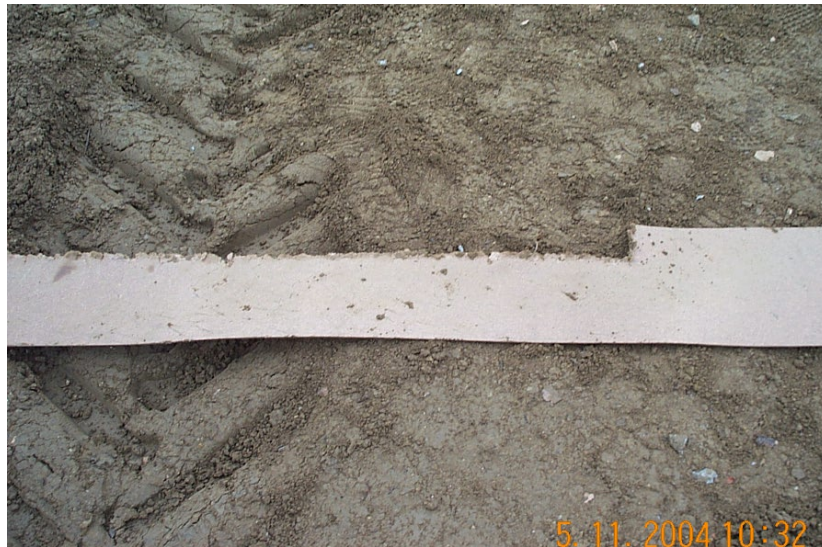
Figure 20 – Damaged fiberboard on the topsoil lane

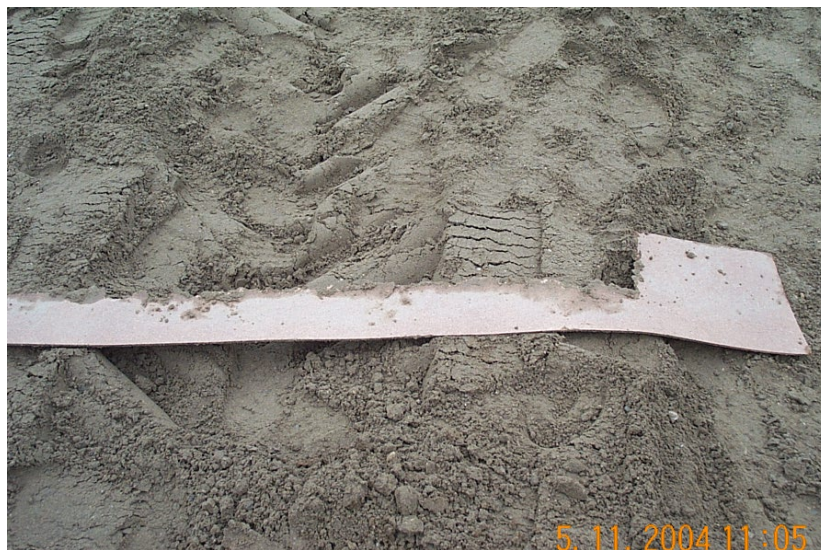
Figure 21 – Damaged fiberboard on the sand lane

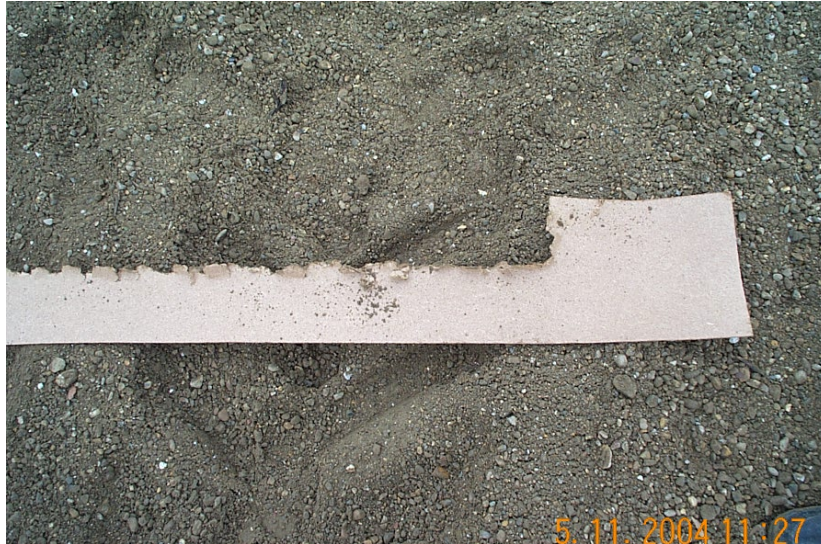
Figure 22 – Damaged fiberboard on the gravel lane

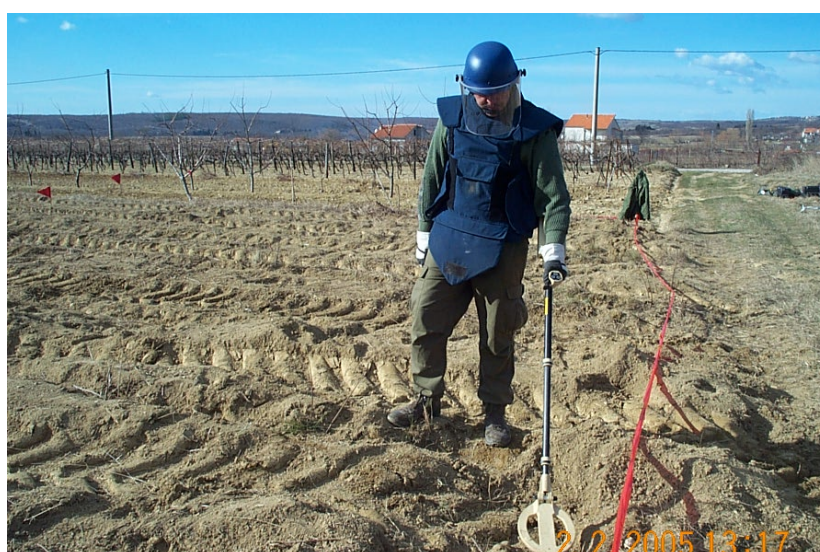
Figure 27 – Deminer's inspection of mechanically treated ground

- There were **12 working days**
- The machine **worked for 685 hours**
- **50,877 m<sup>2</sup> were inspected**
- No remains of mines were found during the inspection
- The number of false alarms on metal detectors was very high because there was a certain quantity of wire on the land, which the machine partly cut in pieces.
- The average surface area inspected by one deminer's shift was **371.35 m<sup>2</sup>/1 deminer/5 h**
- Efficiency of one deminer in inspection of mechanically processed land of I. class is **350-450 m<sup>2</sup>/1 deminer/5h**
