**REPUBLIC OF CROATIA  
CROATIAN MINE ACTION CENTRE -  
CENTER FOR TESTING, DEVELOPMENT AND TRAINING**

**„SAMSON 300 “DEMINEING MACHINE  
TESTING REPORT**

Sisak, February 2005

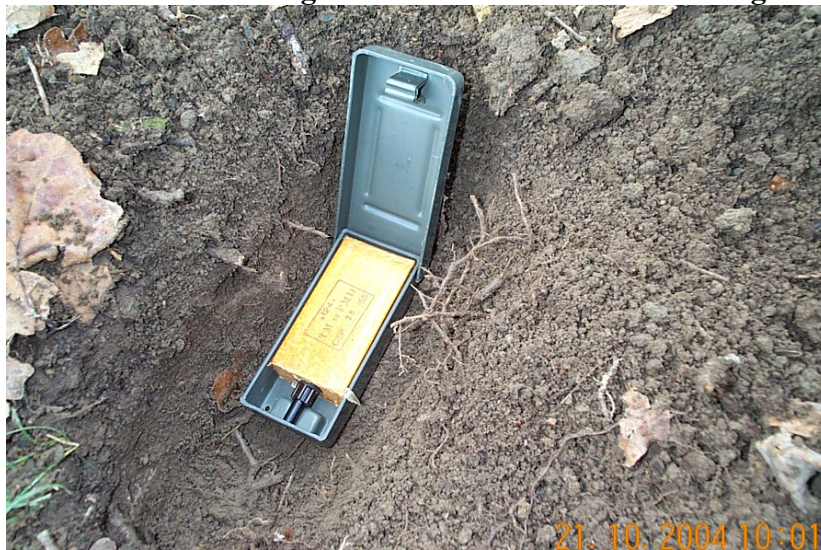
- a) **PMA-1A** – 5 mines were placed at the planned depth (5,10, 10, 15 and 20 cm) at 4 m distance and armed with appropriate fuses. The machine activated the **1., 2., 4. and 5. mine** (at a depth of 5, 10, 15 and 20 cm). The mine in the position 3 (10 cm) was shattered. **Neither the working tool nor the machine was damaged.**

Figure 4 – PMA-1A mine prepared for testing

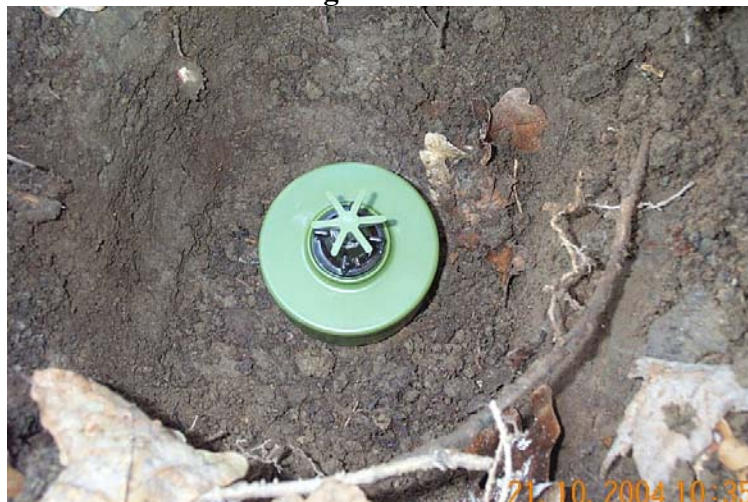
- b) **PMA-2** – 5 mines were placed at the planned depth (5, 10, 10, 15 and 20 cm) at 4 m distance and armed with appropriate fuses. **The mines in positions 1, 2, 3 and 4** were activated (at 5, 10, 10 and 15 cm) by the machine. The mine in position 5 (at 20 cm) was shattered. **Neither the working tool nor the machine was damaged.**

Figure 5 – PMA-2 mine prepared for testing

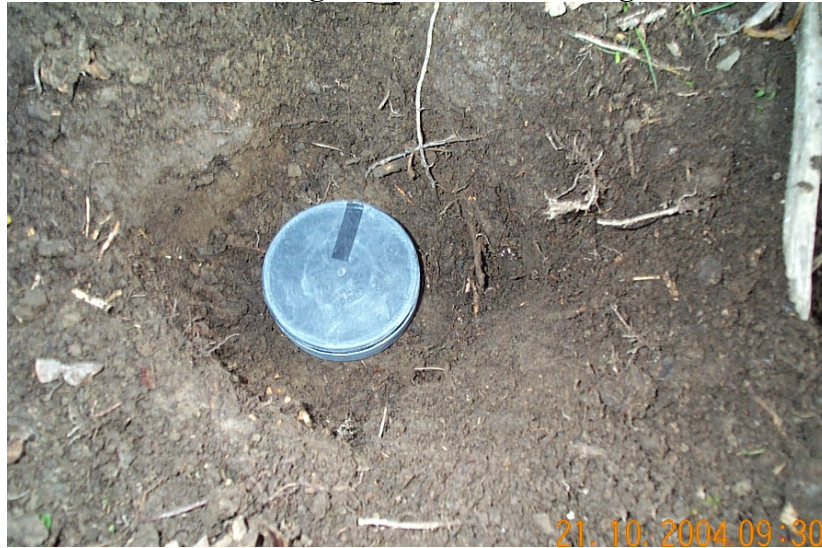
- c) **PMA-3** – 5 mines were placed at the planned depth (5, 10, 10, 15 and 20 cm) at 4 m distance and armed with appropriate fuses. **All mines were activated by the machine. There was no damage either to the working tool or to the machine.**

Figure 6 – PMA-3 mine prepared for testing

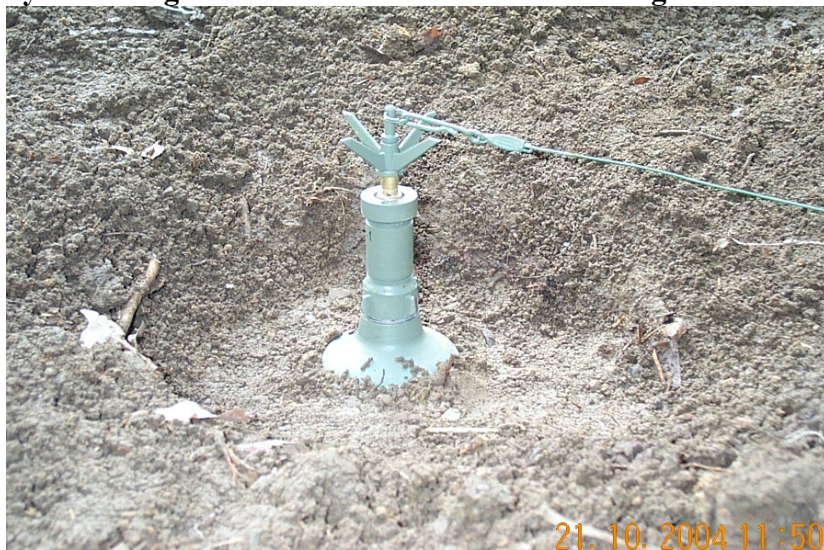
- **First mine** was placed and prepared for tripwire activation. **The mine was activated** by the machine; **the working tool was damaged at some 20 spots** by mine fragments. **The flail cover was penetrated in three places.** **The machine was not damaged.**
- **Second mine** was placed and prepared for pressure activation. **The mine was activated** by the machine; **the working tool was damaged at some 20 spots** by mine fragments. **The machine was not damaged.**

Figure 9 – PROM-1 mine prepared for testing

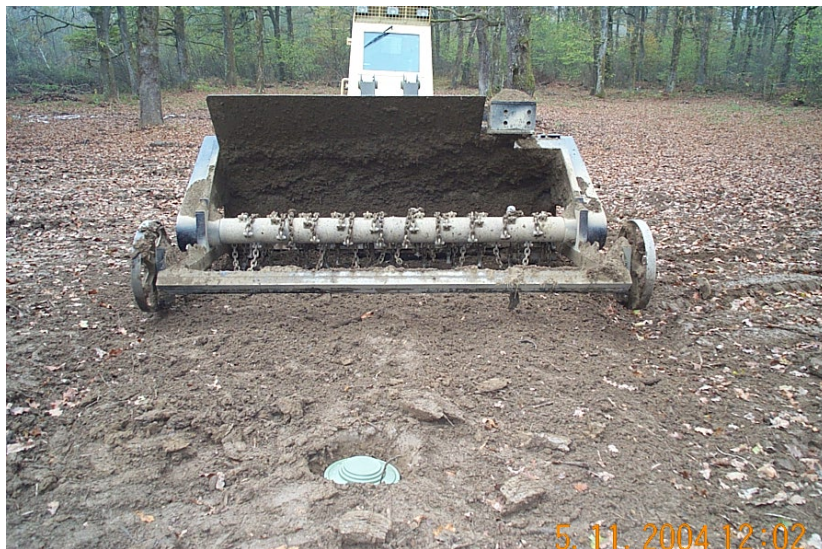
- a) **TMM-1** mine was placed in front of the working tool (in the middle part of the flail) at around 2 m distance, buried at a 10 cm depth and armed with appropriate fuse. **The mine was activated by the machine and the working tool. The machine and the flail had the following damage:**
- **4 chains with striker heads were knocked off**
  - **1 striker head was knocked off**
  - **the flail cover was deformed**
  - **the vegetation rod was deformed**

Figure 15 – TMM-1 mine prepared for testing

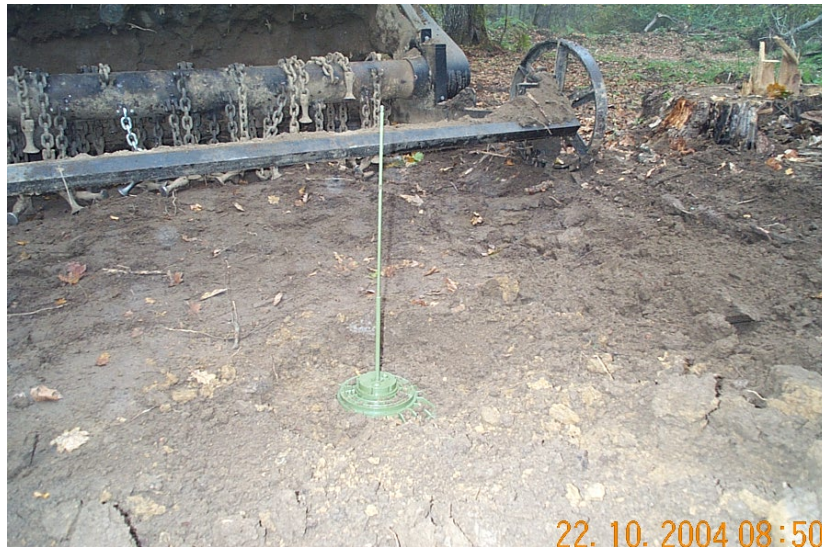
fuse for tilt road activation. **The mine was activated** by the working tool. **The following damage was caused to the machine and the working tool:**

- **The vegetation rod was broken in the middle**

Figure 16 – TMRP-6 mine prepared for tilt rod activation

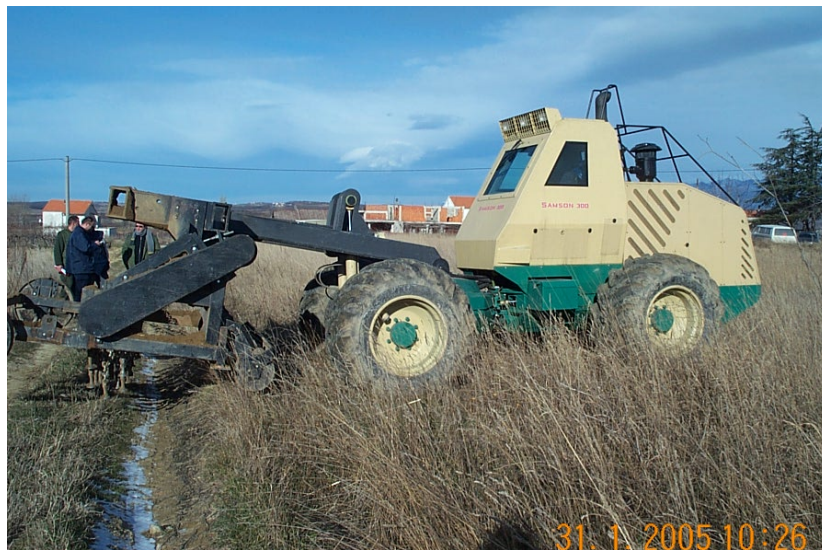
Figure 23 – „Samson 300“ at the beginning of the testing on a demining site

- Mine situation: - There are no minefield records
- The machine was working from 10:20 to 17:00, **4 hours and 45 minutes of effective work**
- **The machine treated 5,418 m<sup>2</sup> of ground, i.e. an average of 1,140.63 m<sup>2</sup>/h**
- **The soil treatment depth was measured on 30 samples, and the average depth was 21.9 cm**
- The machine did not activate any mines

- The machine work was stopped for 7 times: there were six 15-minute stand-stills due to traffic regulation and 1 stand still for fuel refill
- There was no malfunctioning or damage to the machine during the work. 3 striker heads were knocked off from the flail.
- There were no other Testing Committee members present than the testing leader

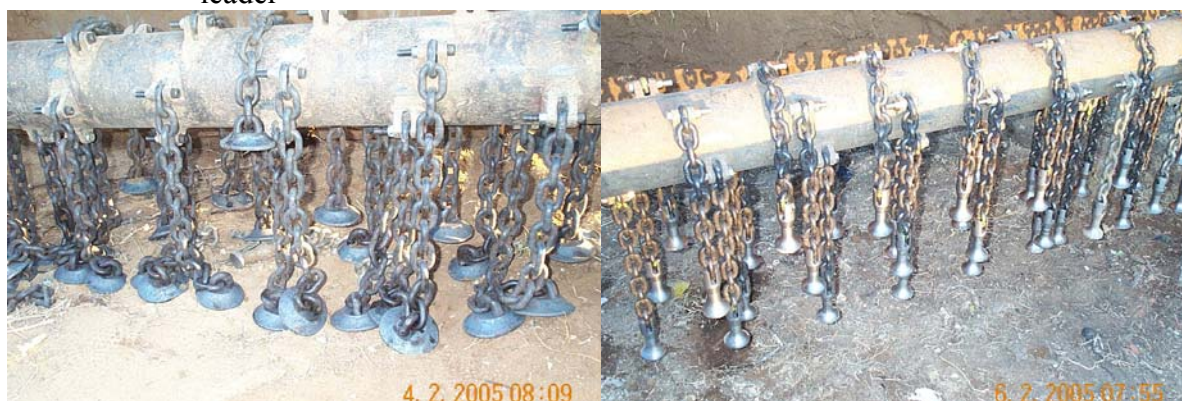
- **Soil treatment depth was measured in 30 samples, and the average depth was 20.66 cm**
- No mines were activated by the machine
- The work had to be stopped 3 times for the purpose of removing the wire wrapped around the flail. At 14:00 o'clock the oil started leaking at a joint of a hydraulic hose. After a washer was changed and the machine worked for 20 minutes, the oil started leaking again and the rest of the time was spent in finding the original washer.

Figure 26 – chains with striker heads
